Pump Rebuild Report

Ingersoll-Rand 3HMTA 8 Stage Pump #1

December, 2016

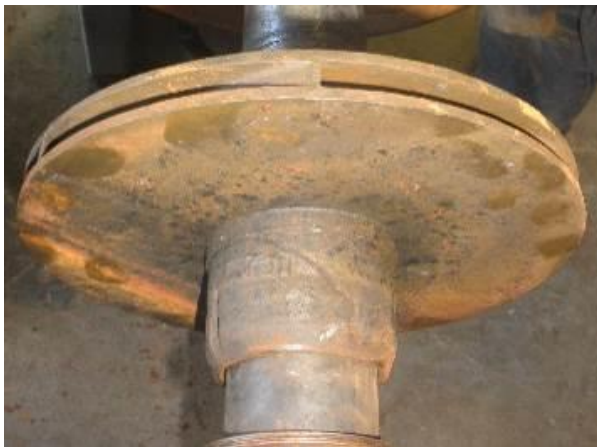
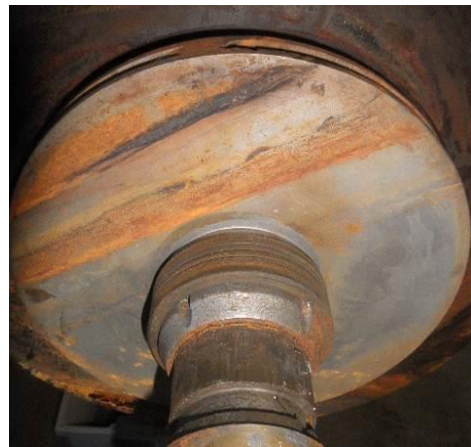
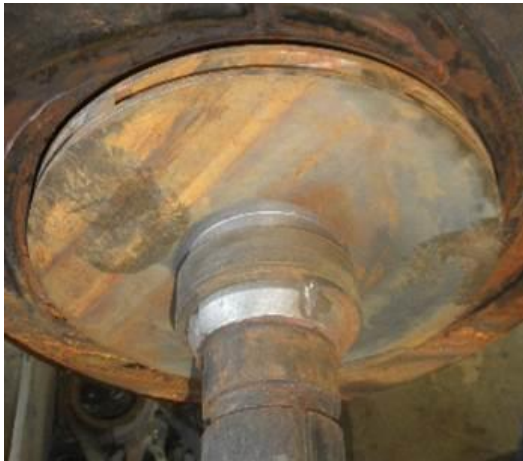
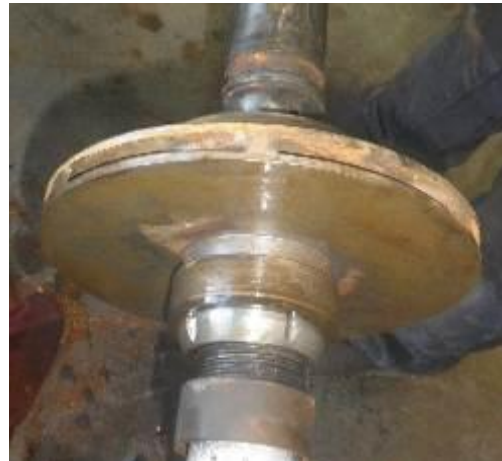
The impellers found in pump #1 were in great condition but were rusted. They did not require any physical repairs but needed to be blasted to get rid of all the surface rust. The O.D. of the impeller's wear ring were slightly large. Pictures of the impellers original conditions on the shaft can be seen below.

Figure 1: Original Impeller Condition on Pump Shaft

Figure 2: Original Impeller Condition on Shaft

Figure 3: Original Impeller Condition on Shaft

Figure 4: Original Impeller Condition on Shaft

All impellers were blasted to remove all surface rust. Eye rings on a number of the impellers were machined down to fit the diffusers accordingly. Pictures of the impellers after completion are seen below.

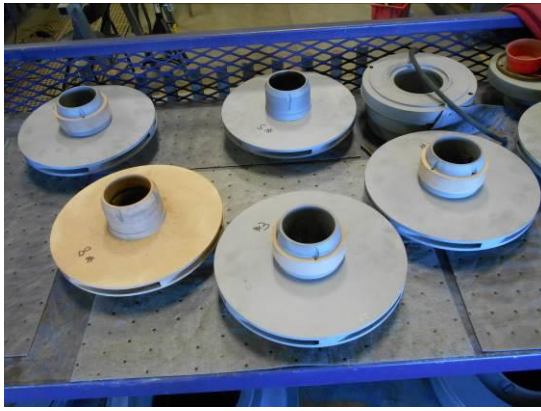
Figure 5: Impellers Sand Blasted

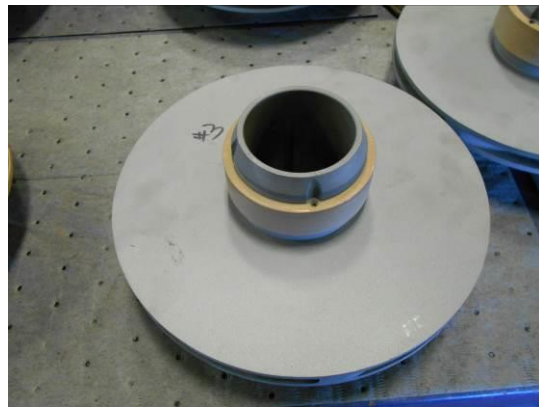
Figure 6: Impeller #3 Close Up

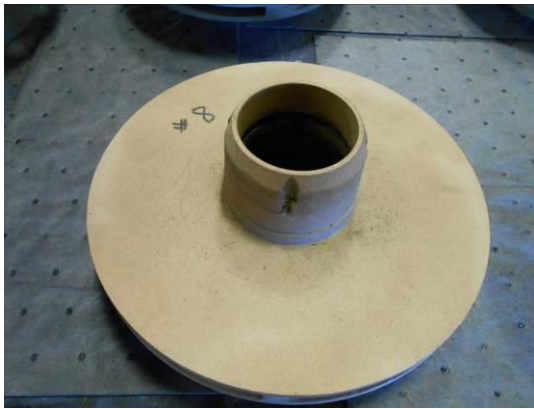
Figure 7: Impeller #8 Close Up

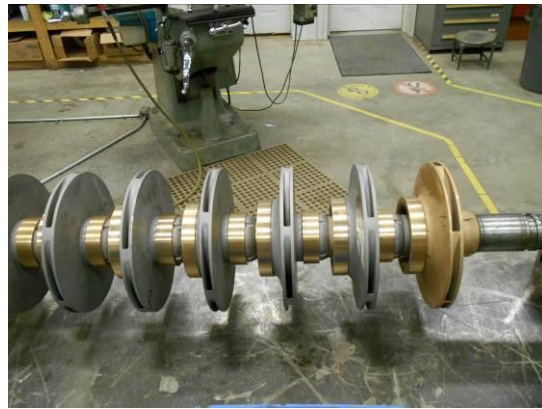
Figure 8: Impellers Back on Shaft

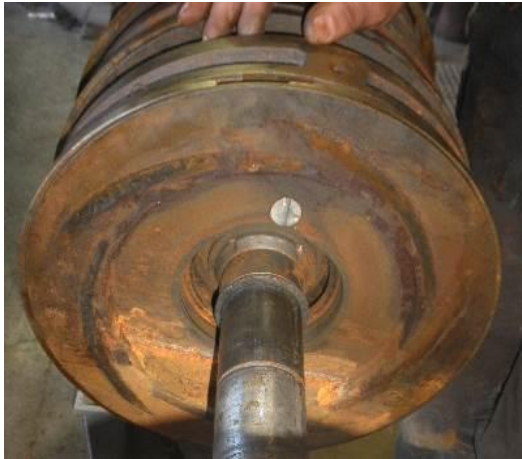
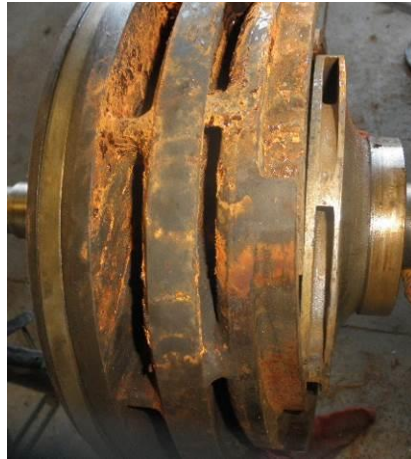
Diffusers were rusted from sitting in the pump for so long but were in great condition otherwise. The hub rings for the diffusers were found to be too large and were scrapped.

Figure 9: Original Diffuser on Shaft, Front View

Figure 10: Original Diffuser Condition Side View

Diffusers were blasted and cleaned to a near white metal finish. While shipping (1) diffuser from pump #1 to the foundry to make an additional diffuser for the missing stage on pump #2, the diffuser cracked during transportation, requiring an additional diffuser to be made for pump #1. In addition, new hub rings were created for the diffusers with a smaller diameter I.D.

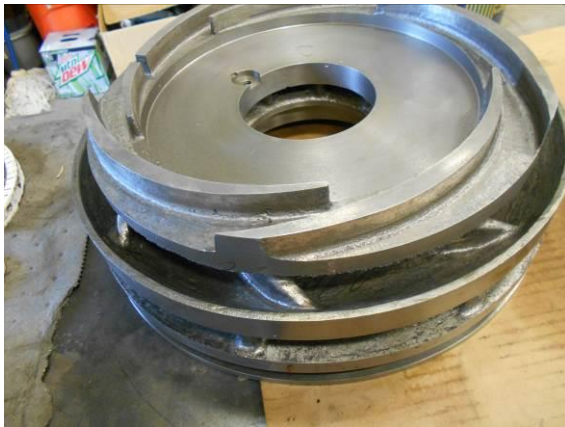
Figure 11: New Diffuser Stacked on Sand Blasted Diffusers

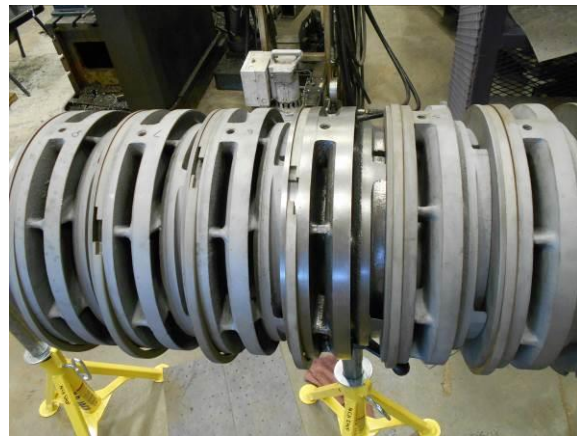
Figure 12: Diffusers on Shaft

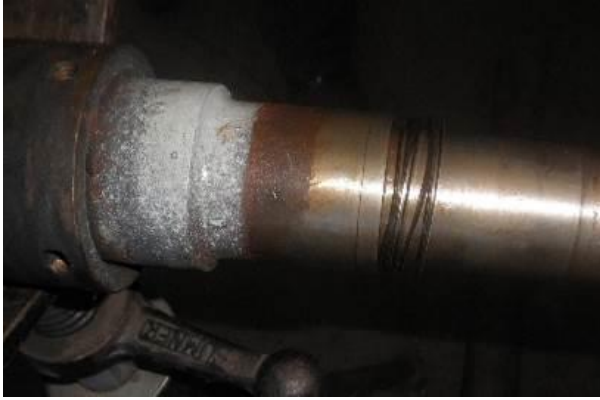
The shaft was in good condition but did exhibit rust and deposits in specific areas.

Figure 13: Paint on Shaft to be Removed

Shaft was blasted and cleaned to remove all rust deposits. Runout was checked on the shaft at the thrust end seal fit, drive end seal fit and at the center of the shaft, all passing API standards.

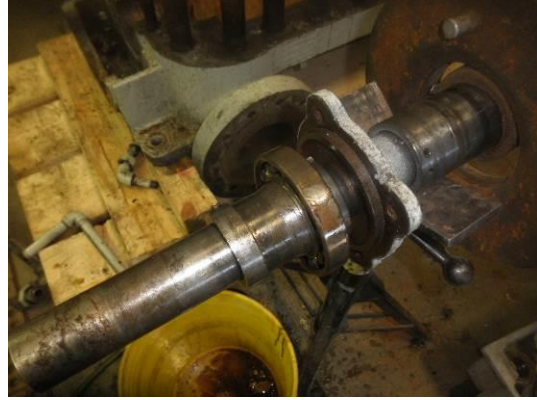
Figure 14: Shaft End Condition

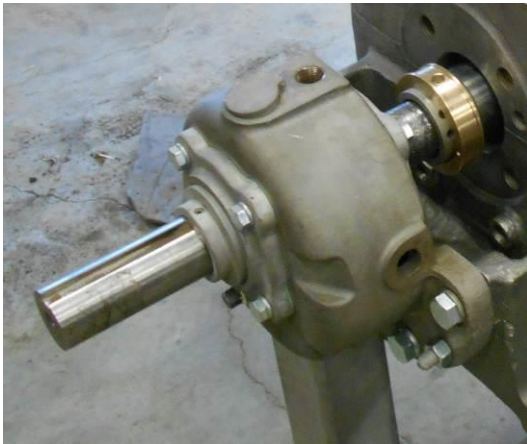
Figure 15: Drive End Shaft Repaired

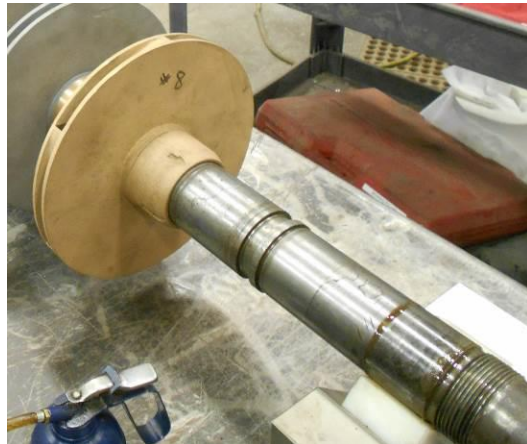
Figure 16: Thrust End Shaft Repaired

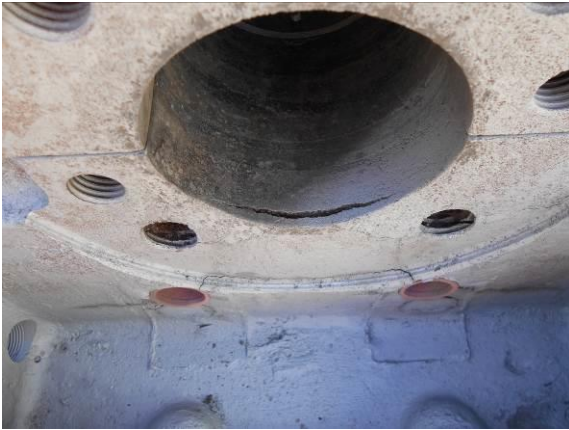
1. Water Jacket Cracked – Water jacket was severely cracked. Damaged area was excavated of bad material and rewelded shut. Jacket was air tested to ensure it was water tight.
2. Bearing Housing Cracked – The bearing housing was cracked in the area for water cooling. Bearing housing was sealed with weld and tested to ensure it did not leak.

The pump casing was in the worst condition of all the pump parts. The water jacket was cracked and could not hold water. In addition, buildup of debris had entered into the cracks. Cleaning of the cracks was required before any welding could occur on them. Finally, corners of the pump were either chipped or worn from wash out. Pictures of the damaged areas are shown below.

Figure 17: Pump Water Jacket Cracked

Extensive work was completed on the water jacket. The cracks had to excavated and cleaned multiple times to get all the debris and foreign material out of the pump. A plate was inserted into the excavated area and welded in place. Weld filled the remaining area and the entire jacket was tested with air to ensure it was water tight. All holes ruined from the process were redrilled and the face was machined flat. The cracks on the corners were all filled with weld and then machined flat to the original pump face. The pump casing was then sand blasted to near white finish and the external was painted high heat silver, per customers request.

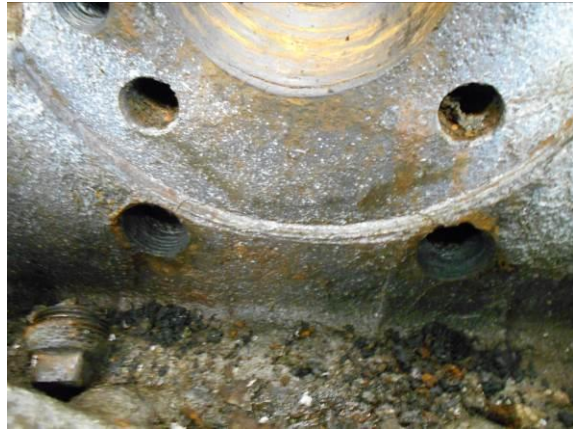
Figure 18: Debris from Cracks Cleaned Out

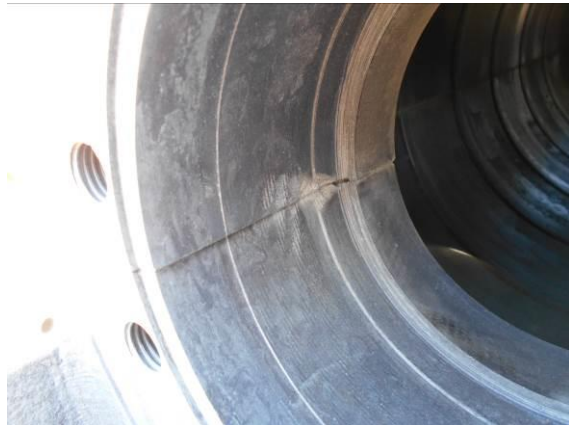
3. Pump Casing Corners Washed Out – Corners of the casing located around the bearing housings were washed out. The corners were filled with weld of similar metal and machined flat.

Figure 19: Wear out on Thrust End Left Side

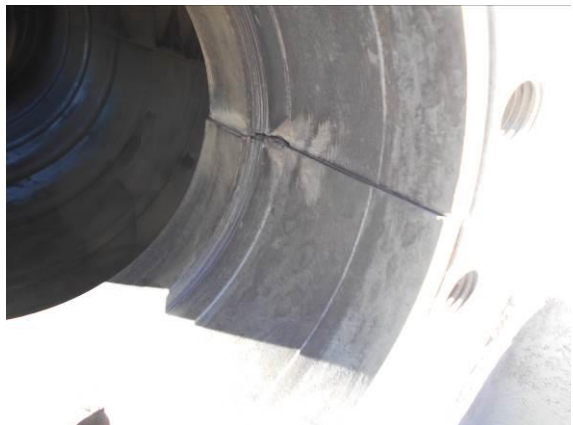
Figure 20: Wear Out on Thrust End Right Side

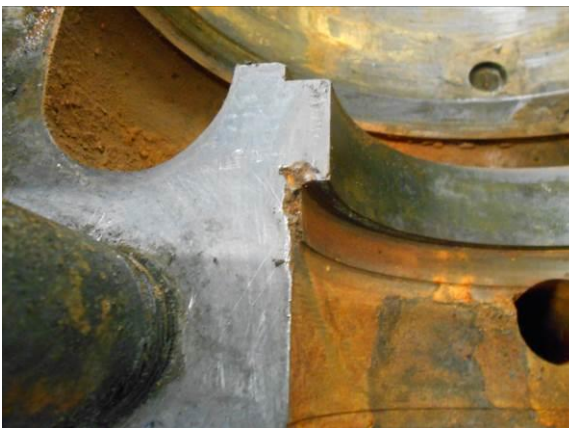
Figure 21: Case Bottom Thrust End Left Side

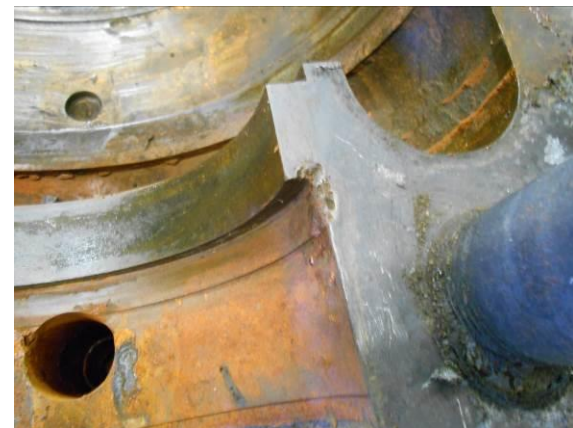
Figure 22: Case Bottom Thrust End Right Side

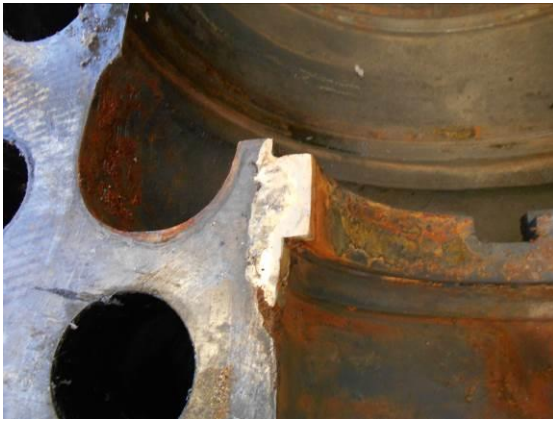
Figure 23: Case Top Thrust End Right Side

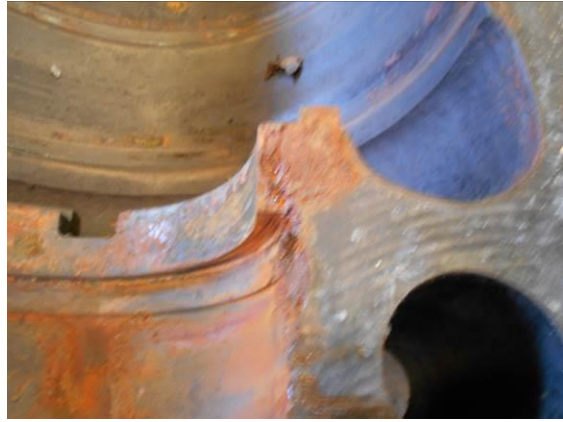
Figure 24: Case Top Thrust End Left Side

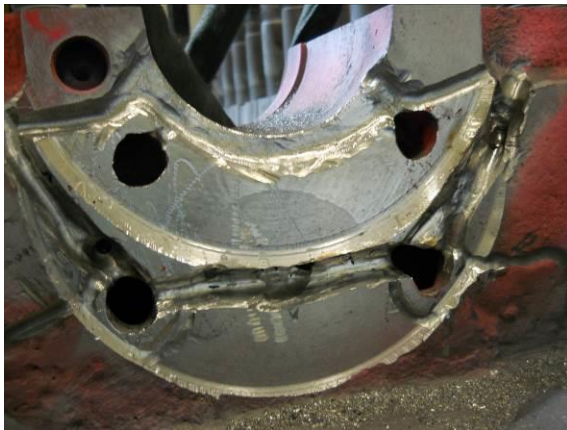
Figure 25: Water Jacket Excavated and Cleaned Out

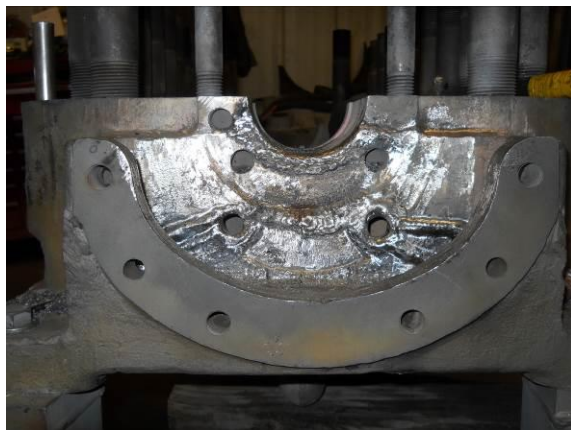
Figure 26: Water Jacket Filled Before Machining

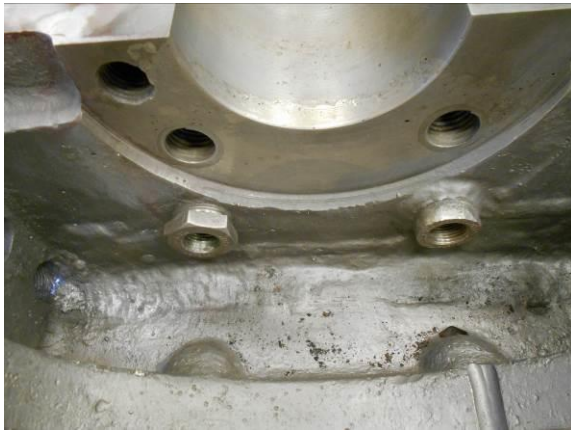
Figure 27: Water Jacket Repaired and Machined

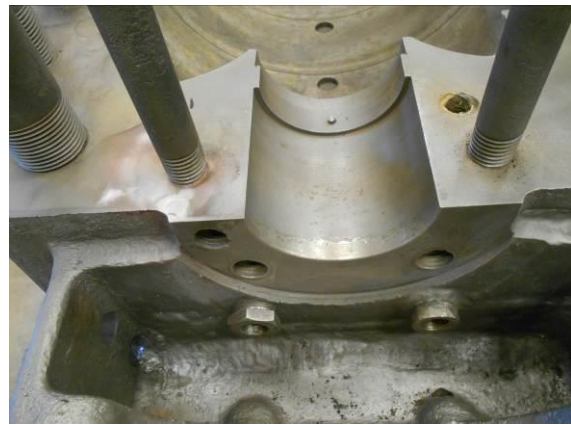
Figure 28: Water Jacket and Corners Repaired

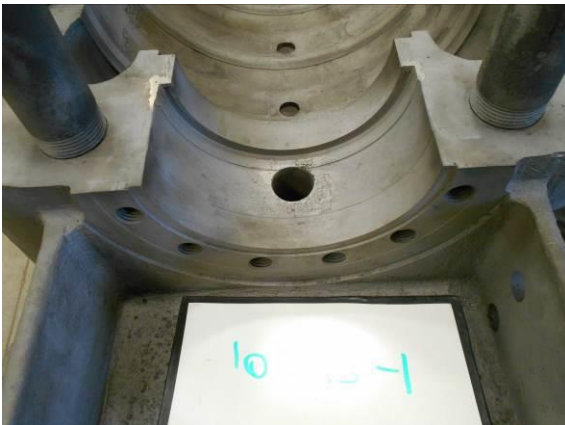
Figure 29: Thrust End Bottom Corners Repaired

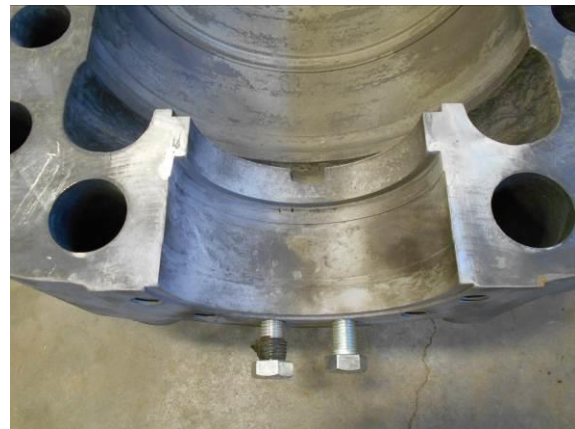
Figure 30: Thrust End Top Corners Repaired

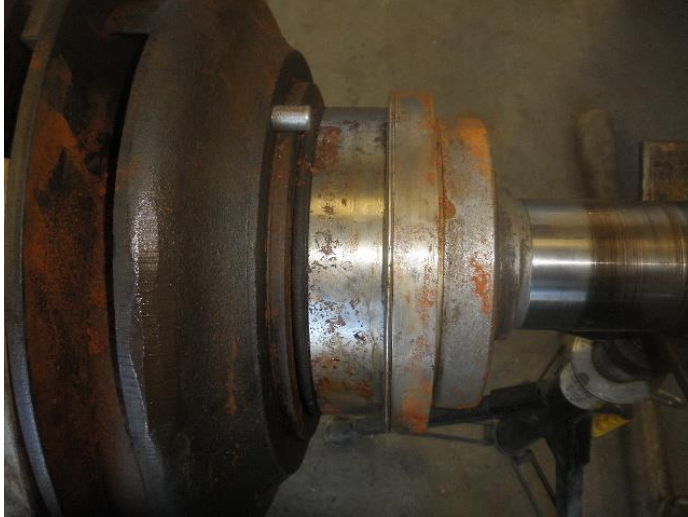
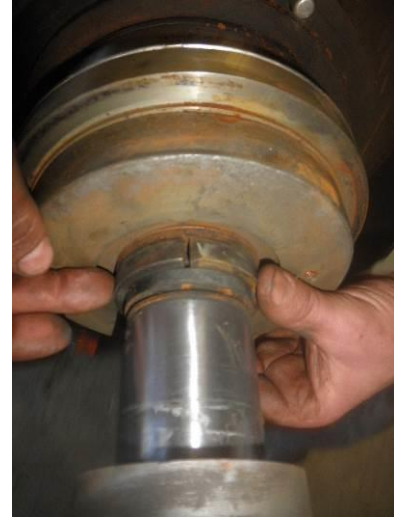
Balance drum had surface rust and required cleaning. Otherwise, it was in good condition.

Figure 31: Balance Drum Side View

Figure 32: Balance Drum Front View

The balance drum was blasted to remove all surface rust. During testing, the thrust bearing was heating up due to excess friction. A 0.003 shim to provide additional clearance was added to the balance drum to increase the back thrust on the pump and reduce the bearing temperature during operation.

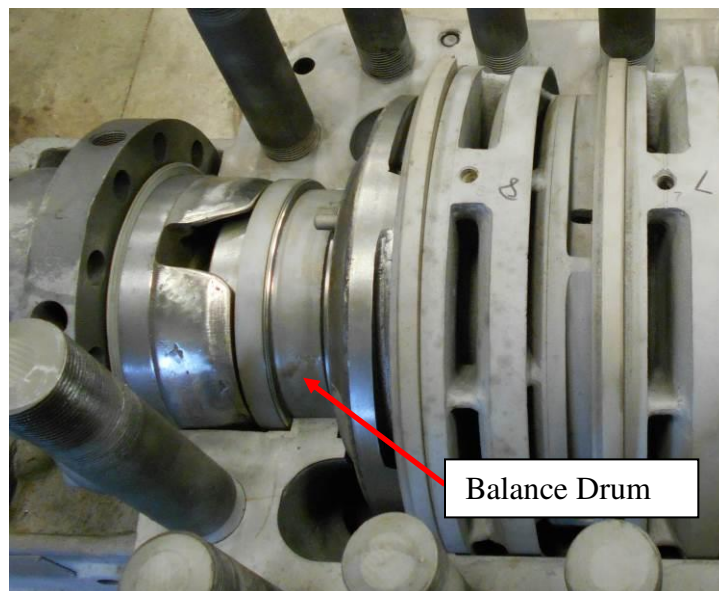
Figure 33: Balance Drum on Thrust End

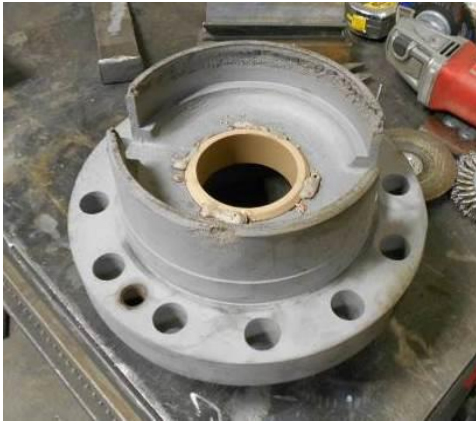
The stuffing box extension exhibited wear on the lip along with surface rust in areas and the bushing was too large. The drive end bushing also exhibited rust and required to be blasted

Figure 34: Stuffing Box Extension with Erosion

The stuffing box extension was welded up and machined down to like new conditions. A new bushing was machined and inserted into the stuffing box extension. The drive end bushing was cleaned up and reinstalled on the pump.

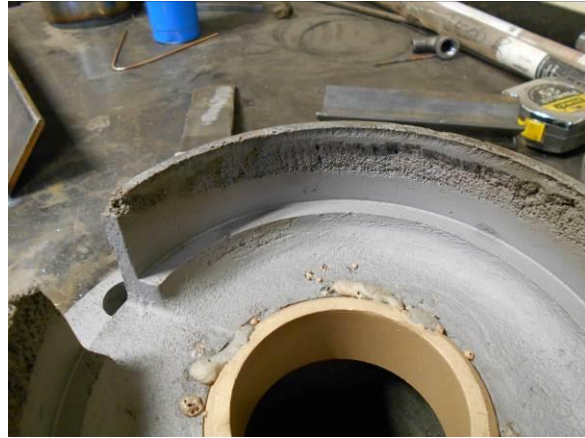
Figure 35: Close Up of Erosion

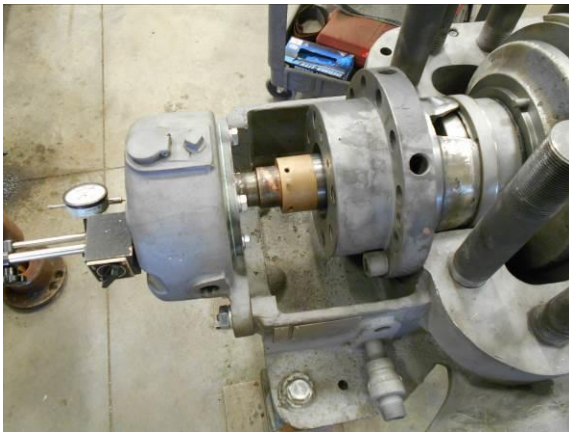
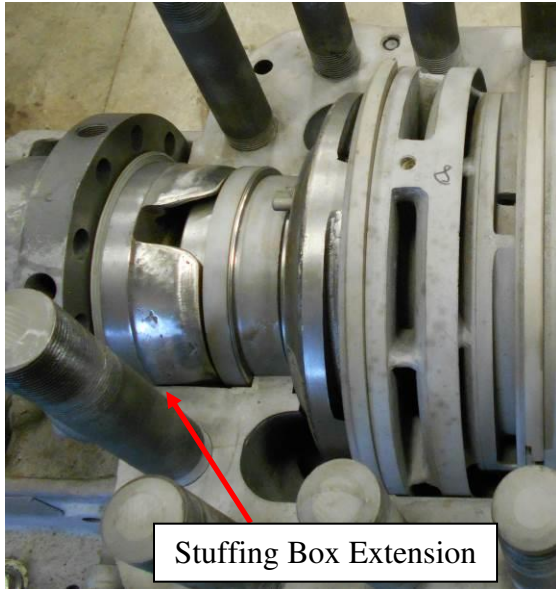
Figure 36: Stuffing Box Extension on Shaft

Figure 38: Stuffing Box Extension on Shaft

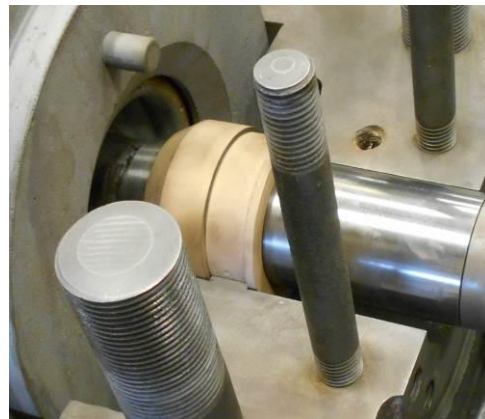
Figure 37: Drive End Bushing on Shaft

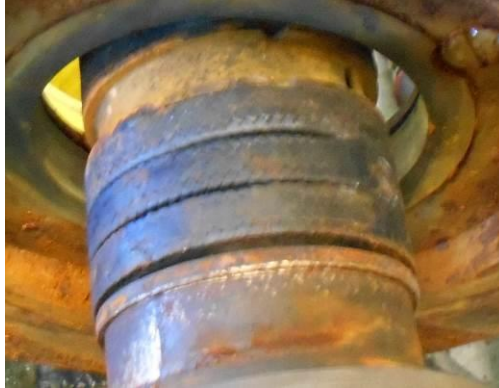
All existing packing was worn, so it was removed and disposed of.

Figure 39: Worn Packing

New Ameri-Lon 690 9/16" packing from American Seals was used for this pump. The packing was cut on an angle using a white plastic mandrel, and installed into the pump using a 1/3 round tool.

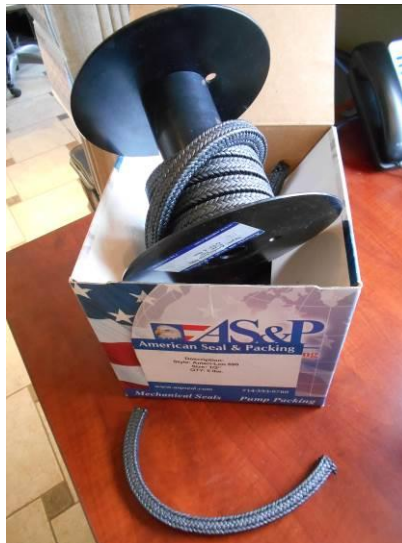
Figure 40: 100% GFO Packing

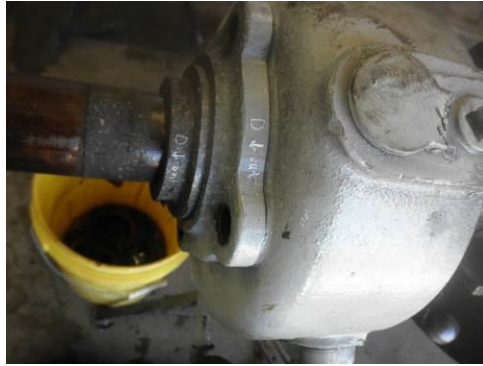
Figure 41: Drive End Bearing Housing

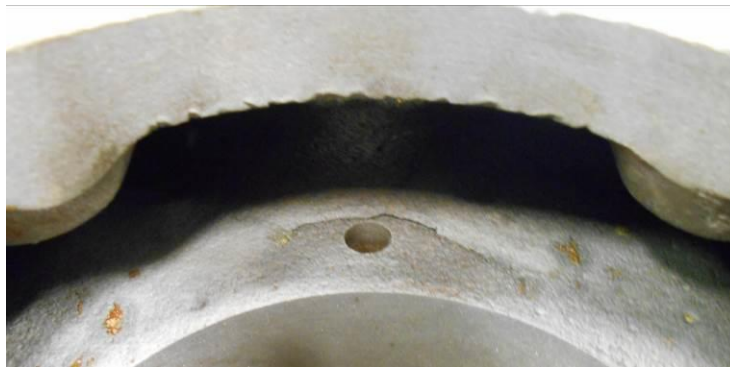
Bearing housings were in good condition, but the thrust bearing had a crack on the interior where the water jacket pushes water into the bearing housing to cool the bearings.

Figure 42: Crack in Bearing Housing

Bearing housing was welded closed and tested with 60 psi air to ensure it was water tight. In addition, it was cleaned up to remove all grease and surface rust.

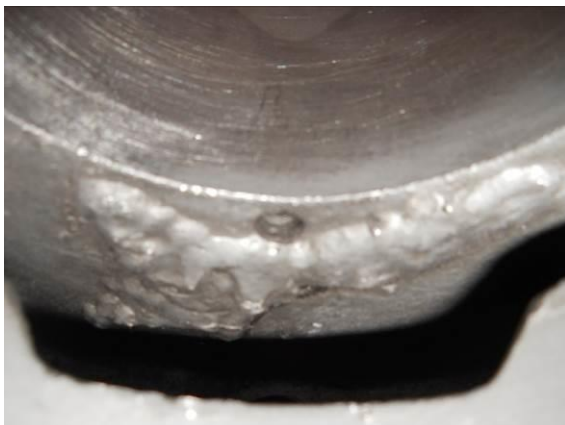
Figure 43: Bearing Housing Crack Fixed

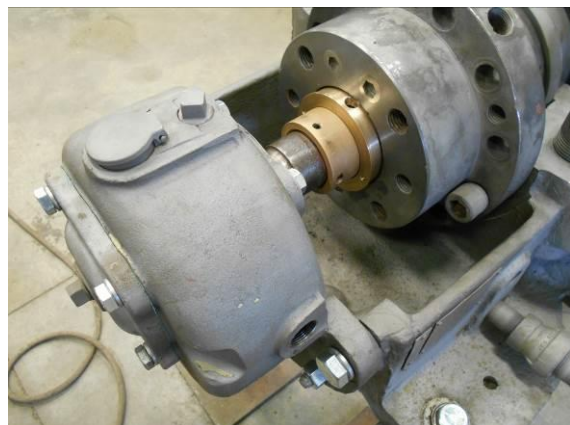
Figure 44: Thrust End Bearing Housing Cleaned and Installed

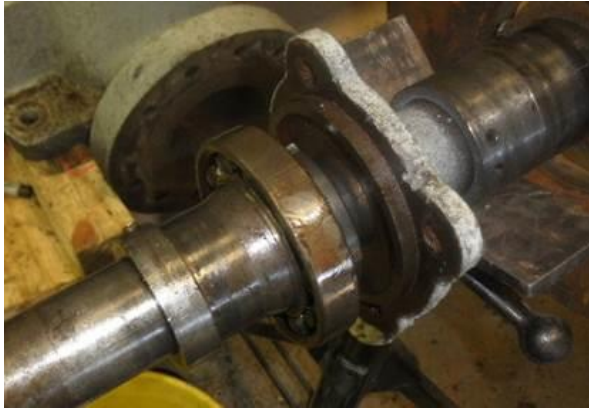
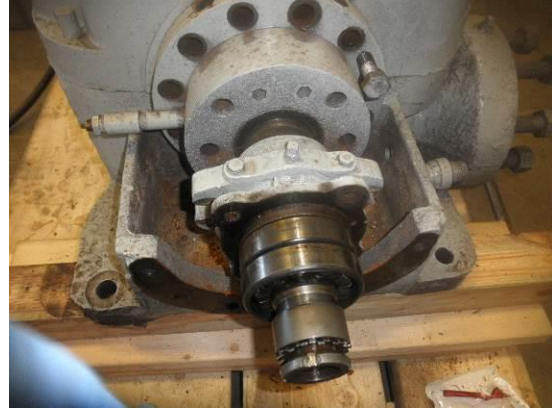
The bearings in the pump were worn and old. They were discarded and new bearings were purchased.

Figure 45: Original Drive End Bearing

Figure 46: Original Thrust End Bearing

New bearings were purchased for both the thrust end and drive end. For the thrust end, KOYO 7408DB Bearings were used and SKF 6213 Bearings were used for the drive end.
